PLATTE COUNTY MEMORIAL NURSING HOME **FACILITY EVALUATION REPORT**

**PLATTE COUNTY
MEMORIAL NURSING HOME**

JUNE 2011

NELSON
ARCHITECTS, LLC.

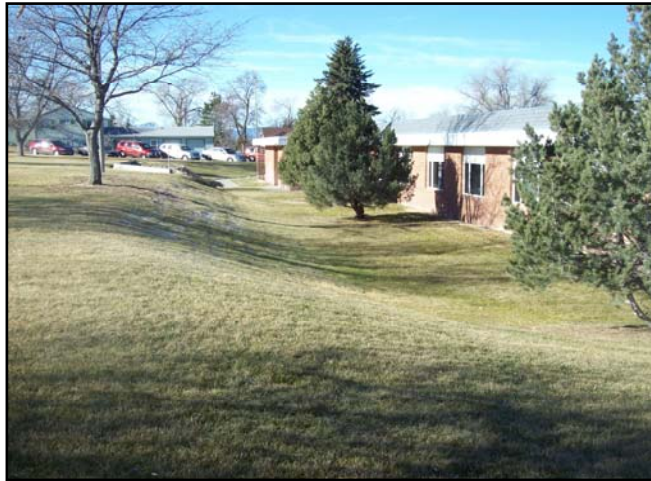
Site: The site is a square city block that creates a 'campus' with the hospital and nursing home situated in the center, creating an opportunity for the nursing home to have expansion potential to the south and southwest. When the 1978 addition to the nursing home was built, plans show that there was some site work to modify the slope around the new addition. The existing slope is such that the Owner has noted that when they get heavy rains, the water runs off the sloped banks and backs up against the foundation until it can drain away. The floor elevation of the building appears to be at the same level as the landscaping and sidewalks which allows the water to come in the south doors of the original building.

Shows the landscaping up against the building.

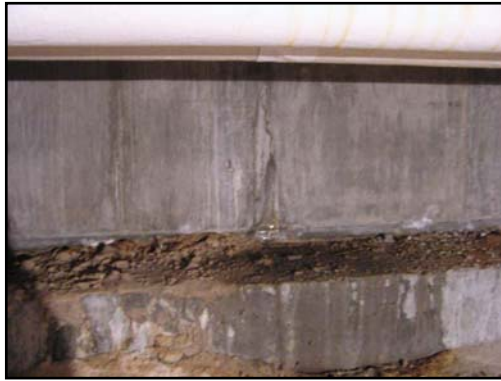
Foundation Walls: The facility is built with the standard continuous spread footers and an 8" wide x 4' high concrete wall. At this time we will presume that the foundation and footers are reinforced. The foundation appears to be in generally good condition with the exception of two cracks in the foundation wall on the 1978 wing of the building. The cracks appear to be near the location where the downspouts drain the water off the roof. The water does not drain away from the building so the freeze/thaw cycles may have caused the cracks in the foundation. The cracks are wide enough that moisture is migrating through the cracks and into the crawl space and the area near the cracks are wet. The cracks can only be seen from inside the crawl space because as noted above, the lawn/sidewalks appear to be at the same level as the finished floor elevation, therefore no foundation is showing on the exterior of the building. The rest of the crawl space is relatively dry.

Crack in the foundation with moisture seeping through.

This crack should be analyzed by a structural engineer. If the crack is not structural then the crack needs to be repaired to keep the moisture out of the crawl space.

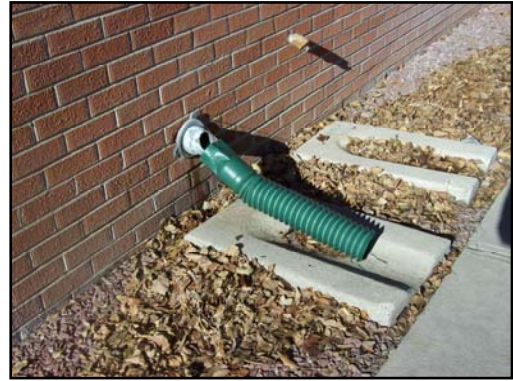
Downspout draining near the building.

The roof drains should be routed underground and drained into several drywells away from the foundation.

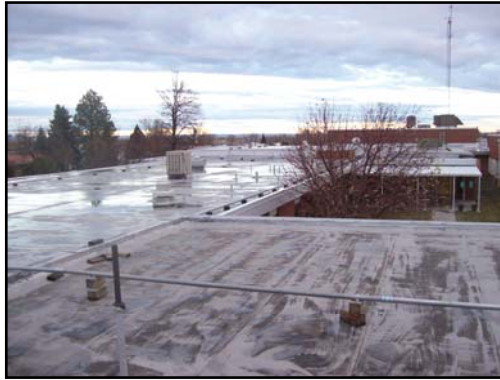
The soft spots could potentially be saturated insulation. When the insulation is saturated, the minimal thermal resistance ('R' value) of the insulation is significantly compromised and the integrity of the plywood decking under the saturated insulation could unknowingly be deteriorating. On the 1978 addition, the area 'D' roof system is a built-up roof with 3 1/2" 'Fesco' foam insulation and 'Fesco' board over a 1-1/2" steel deck that bears on 16" open web steel joists, 4'-0" on center, bearing on the south side of the corridor wall. This roof was installed in 1998 and has had periodic maintenance. The roof drains are internal and drain to the outside of the building and the roof structure slopes slightly towards the drains. There are no over flow drains on this section either so the excess water builds up on the roof before it drains down the main roof drains or flows over the edge. With the mansard roof, there is the same problem as the original roof in that the edge flashing is tall, potentially causing significant ponding on the roof if a roof drain is plugged or cannot drain an adequate amount of water.

noted by the Owner that the wood roof joists that are butted up to the hospital wing on the north side of the facility are rotting and difficult to maintain. This roofing system provides only a small amount of thermal insulation as part of the thermal envelope. Areas 'A', 'B' and 'D' could be repaired, but this would only extend the life of the aging roof approximately 7 years while repairs on Area 'C' would only extend the life of the roof up to 5 more years. The age and condition of the existing roof system indicates roof replacement should be a top priority.

View from area 'D', ponding on area 'C'.

A forensic investigation of the existing roof system would be recommended before any remodeling takes place. The entire roof system beginning with the roof decking, should be replaced with a membrane and tapered insulation system with a vapor barrier and cover board. The increased insulation will help to reduce cooling and heating loads, lower energy costs and reduce pollution and carbon emissions. The minimum industry recommendation, ASHRAE STANDARD 90.1 zone 5, for above roof deck insulation for commercial buildings is R-value = 20: this standard would be met by approximately (2) layers of 2" polyiso rigid insulation. With the recommendation of a tapered roof system, the edge flashing and fascia would need to be replaced and added to in height. With the additional height to accommodate the tapered insulation, wall scuppers could be added as an overflow drain option.

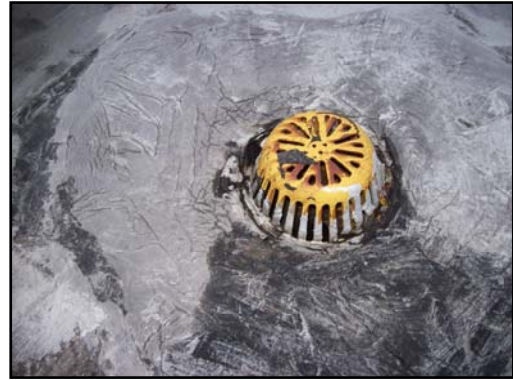
Typical roof drain.

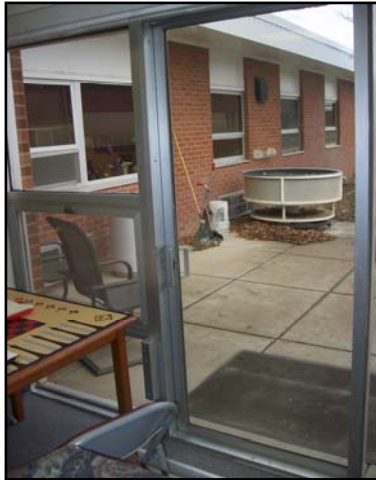
Exterior Windows: The existing storefront units in the 1964 portion of the facility are single pane, clear glass with non-thermally broken aluminum frames which have a very poor performance for thermal resistance. The 1978 addition has metal clad, double paned wood windows that have the seals broken in them and therefore have an equally poor performance.

Single pane, clear glass

Replacement of both the windows and aluminum storefront windows would significantly reduce heat gain/loss, air leakage and solar heating of the building. Ideally, the upgraded windows would be a multiple pane system that has thermal breaks, a low transmission of solar radiation and a high thermal resistance. Window performance recommendations are U-value = 0.45 and an SHGC = 0.40. Replace the aluminum storefront windows with a combination of insulated frame walls and a reduced amount of glazing for better thermal performance.

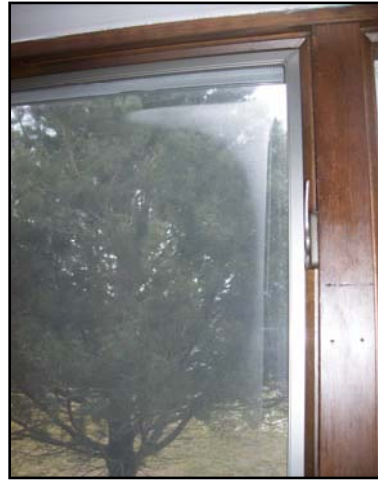
Broken seal between glass.

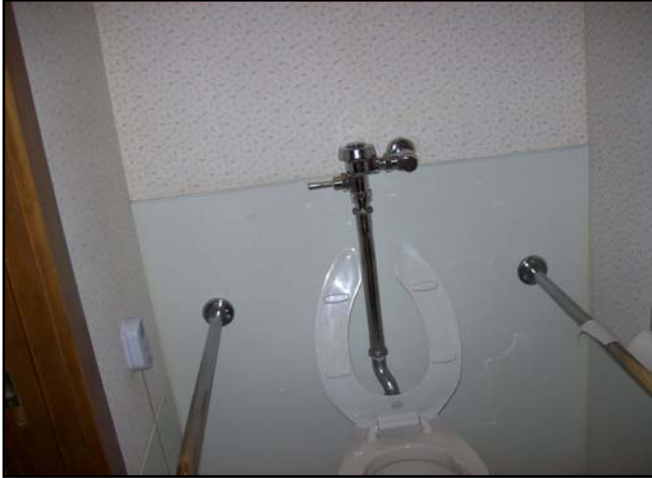
The public restrooms would need renovation to be compliant. Almost all of the toilet and sink fixtures are original to the building and could be upgraded to modern fixtures.

Typical resident room toilet

In the 1964 portion of the building, extend the toilet room in both the width and length to accommodate a hand wash sink and ADA requirements. New resident storage would need to be replaced to accommodate this remodel. The toilet rooms in the 1978 wing would need to be widened and the entry door to the rooms moved to make room for the expansion. The public toilets near the entry of the building need to be enlarged to accommodate the ADA requirements and would likely encroach into the dining area or corridor/entry.

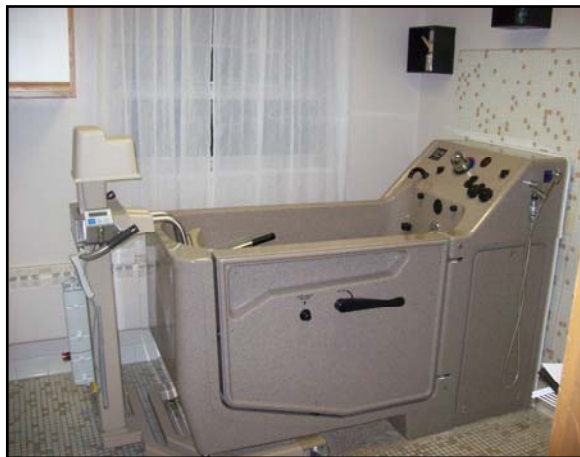
Bathing Facility

with the facility licensed for 43 beds, two bathing facilities are required. The bathing facility in the 1978 wing is very spacious and meets the ADA standards and *Guidelines* with a shower and accessible tub in an individual room with space for private use of the bathing fixtures, drying, dressing and for access to a grooming location containing a hand washing station, mirror and shelf. However, the other bathing facility in the older portion of the building has been remodeled to accommodate an accessible tub, but does not meet with the *Guidelines* requirement of having a separate toilet within or directly accessible to the bathing facility without requiring entry into the general corridor. The resident shower, which is near the bathing facility, also falls short of meeting the same *Guidelines* requirement.

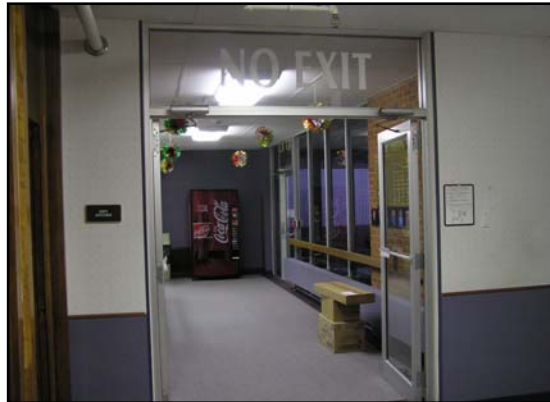
SERVICE AREAS: The administrative area is near the entrance of the nursing home and accommodates the administrator and a secretary. There are two offices near the nurse's station with two occupants each, and another office near the activities area. The administration area does not have the ability to monitor residents or visitors without someone stepping out of the office. There are no provisions within the administration area to accommodate any sort of private conversations or group meetings unless they take place either in the staff lounge or in the private dining room at the far end of the building. In addition to the cramped quarters that the support staff works in, there is very little storage for office equipment & supplies or medical & financial records. The original storage for these items was commandeered into a computer room. The building's original design offered no accommodations for a shipment receiving area for the nursing home because the nursing home was attached to the hospital and the shipments were unloaded at the hospital and distributed to the nursing home. Now that the nursing home is separate, this has created a difficult situation because there is no loading dock or breakout area for receiving medical supplies, equipment or furniture. The receiving area is the corridor to the activities and outdoor area and all of these shipments must come through the 3'-0" main entry door. This is a potential hazard to the residents, unsightly and inefficient, but there is no other area to use for this service.

Corridor used as receiving area.

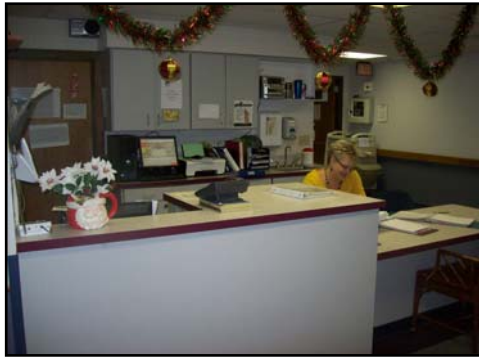
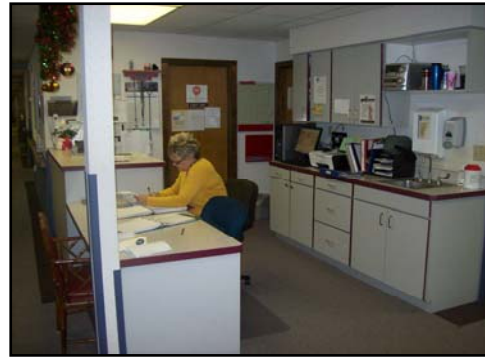
Nurse's Station

The present layout of the nurses' station, which is centrally located between the resident wings and is convenient for the nursing staff to chart, dispense medicine and monitor the residents, is unable to provide any separation between the public corridor and private areas. Before going on duty, nurses usually meet there to receive daily assignments, review resident's charts and update the files, but with the limited space and lack of privacy, the HIPAA regulations cannot be adequately met.
